IsoFlex Technologies Pty Ltd.

IFC-6000-Inst-V2 [11-07]

IsoFlex Flexible Disc Couplings: Installation of the '6000 - series'

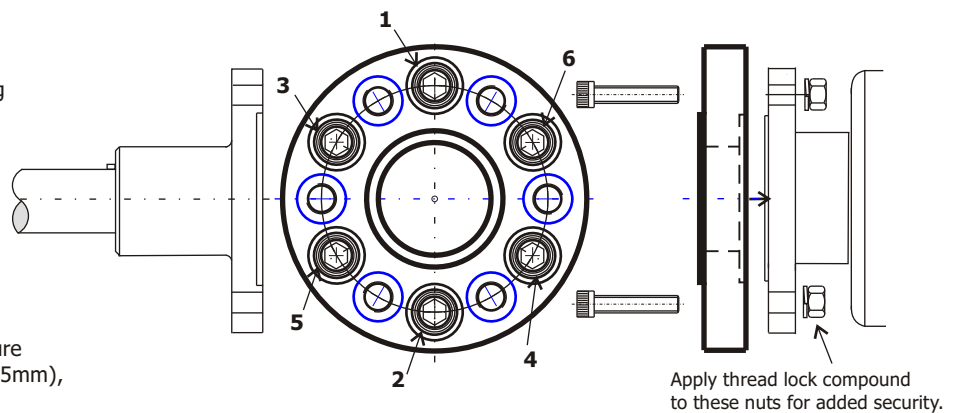
STEP 2.

Remove the flange bolts and part the flanges, fit the coupling to the gearbox output flange by mating the spigots and rotating the coupling to align the drive bushes of the coupling with the flange holes.

Fit the bolts, nuts & spring washers supplied, tightening to the required torque in two steps in the sequence shown. (ie: for a required torque of 70Nm, tighten to 35Nm in the sequence shown then to 70Nm in the same sequence.)

Important Note: It is critically important to measure the spigot depths and heights to ensure that there is a minimum clearance of 0.020"(0.5mm), ie: none of the spigots shall ever 'bottom out'.
